Debris/Ice/TPS Assessment And Photographic Analysis For Shuttle Mission STS-38

February 1991

DEBRIS/ICE/TPS ASSESSMENT
AND
PHOTOGRAPHIC ANALYSIS
OF
SHUTTLE MISSION STS-38

November 15, 1990

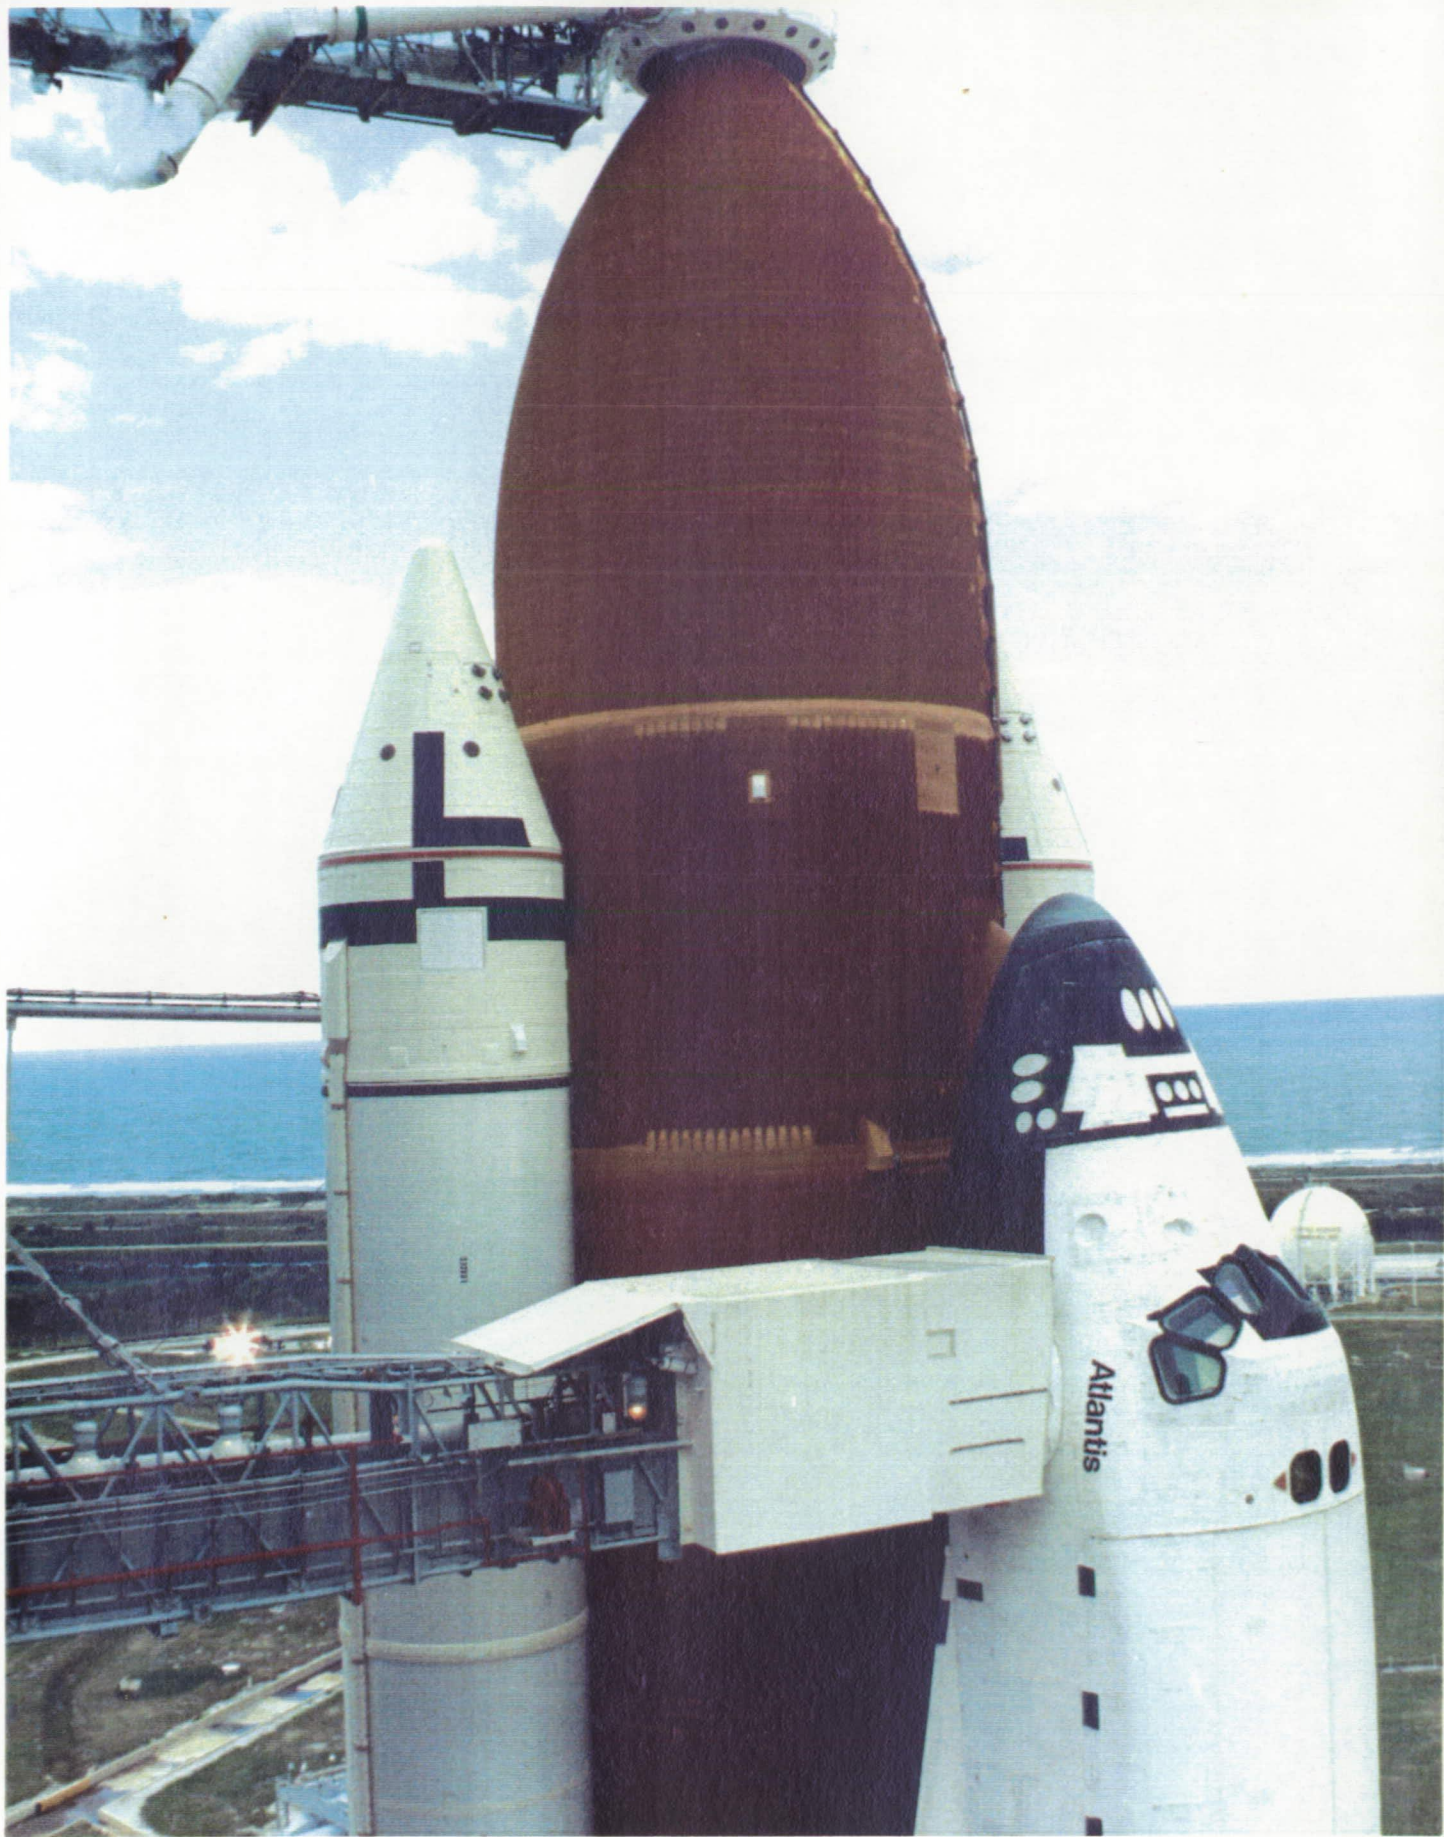
Overall view of ET-40 L02 tank and upper LH2 tank -Y+Z side. No ice/frost had formed on the ET TPS acreage.

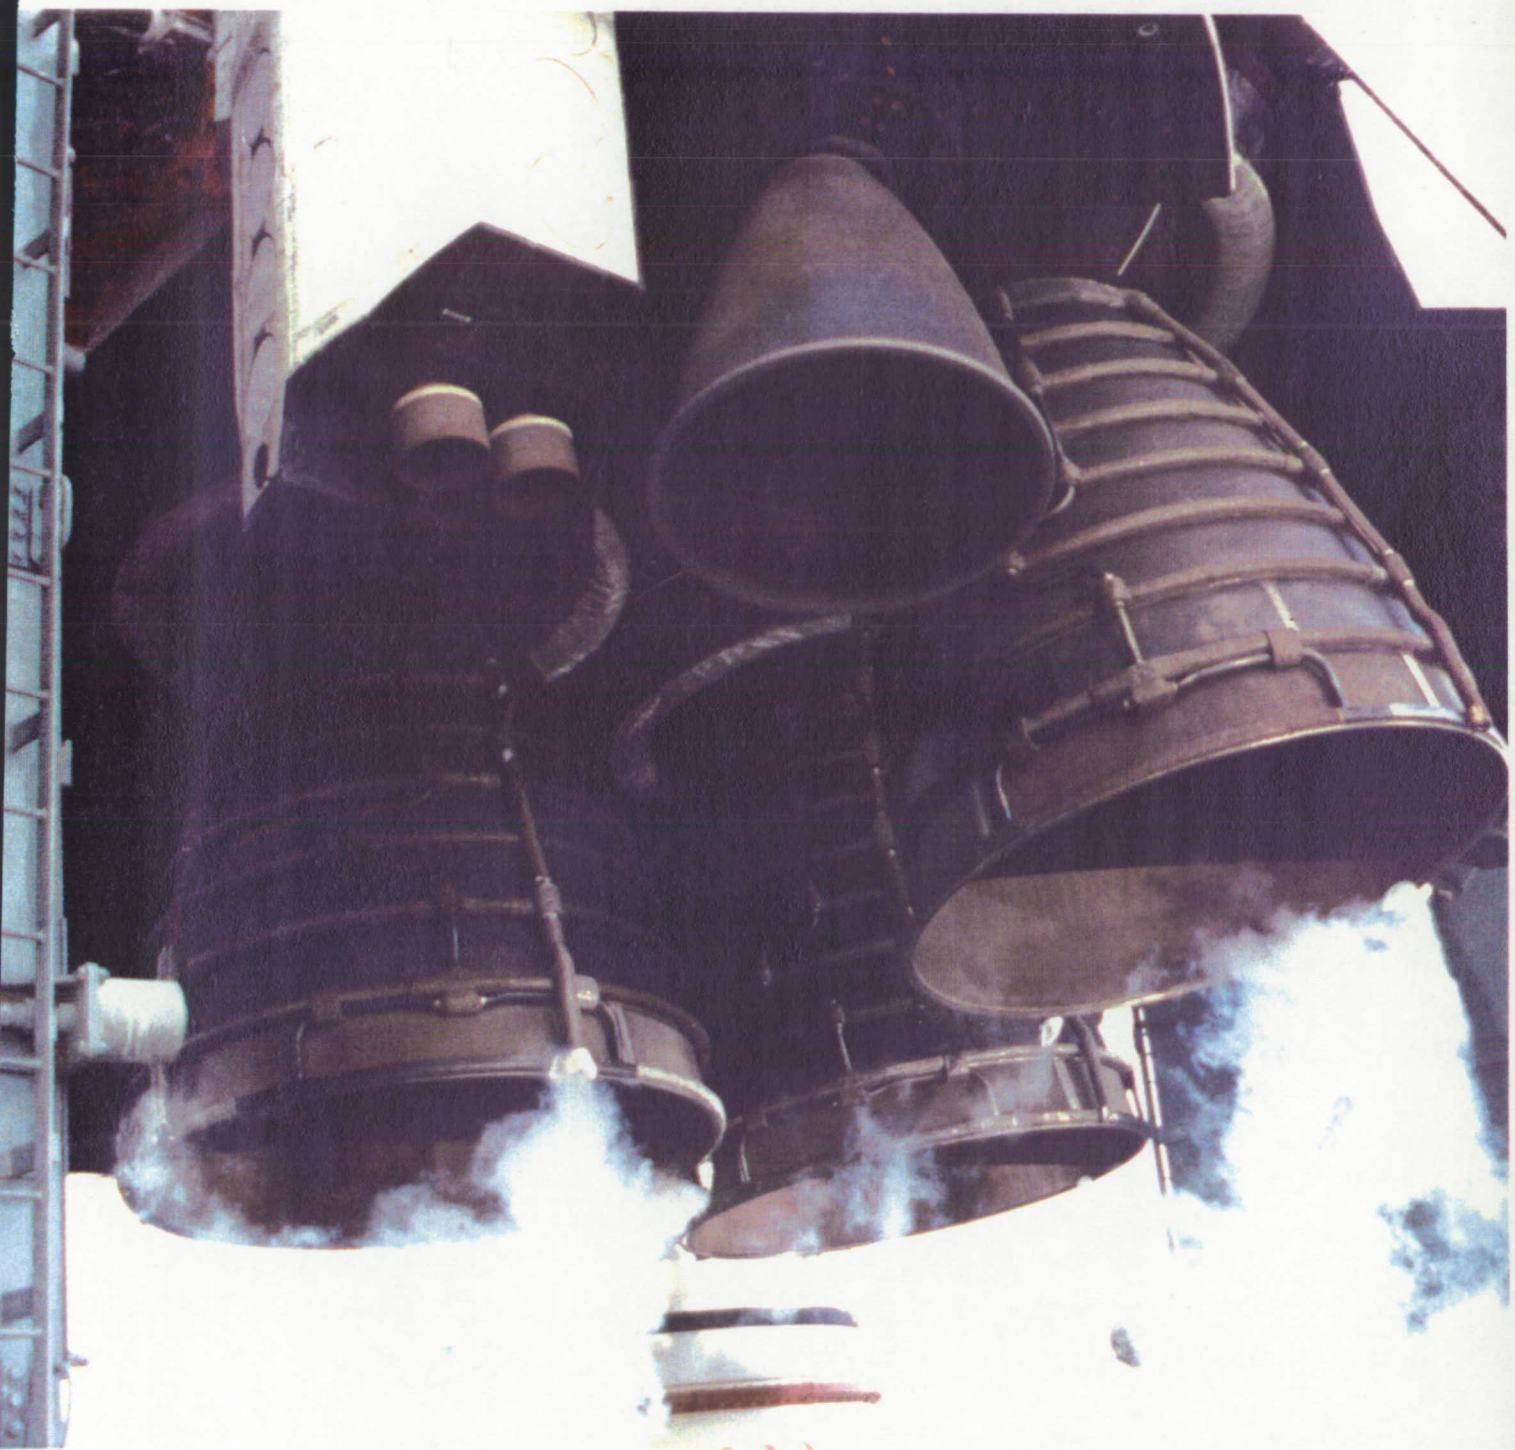
Overall view of SSME's. A small amount of ice/frost had formed on the SSME #1 and #2 engine mounted heat shield interfaces.

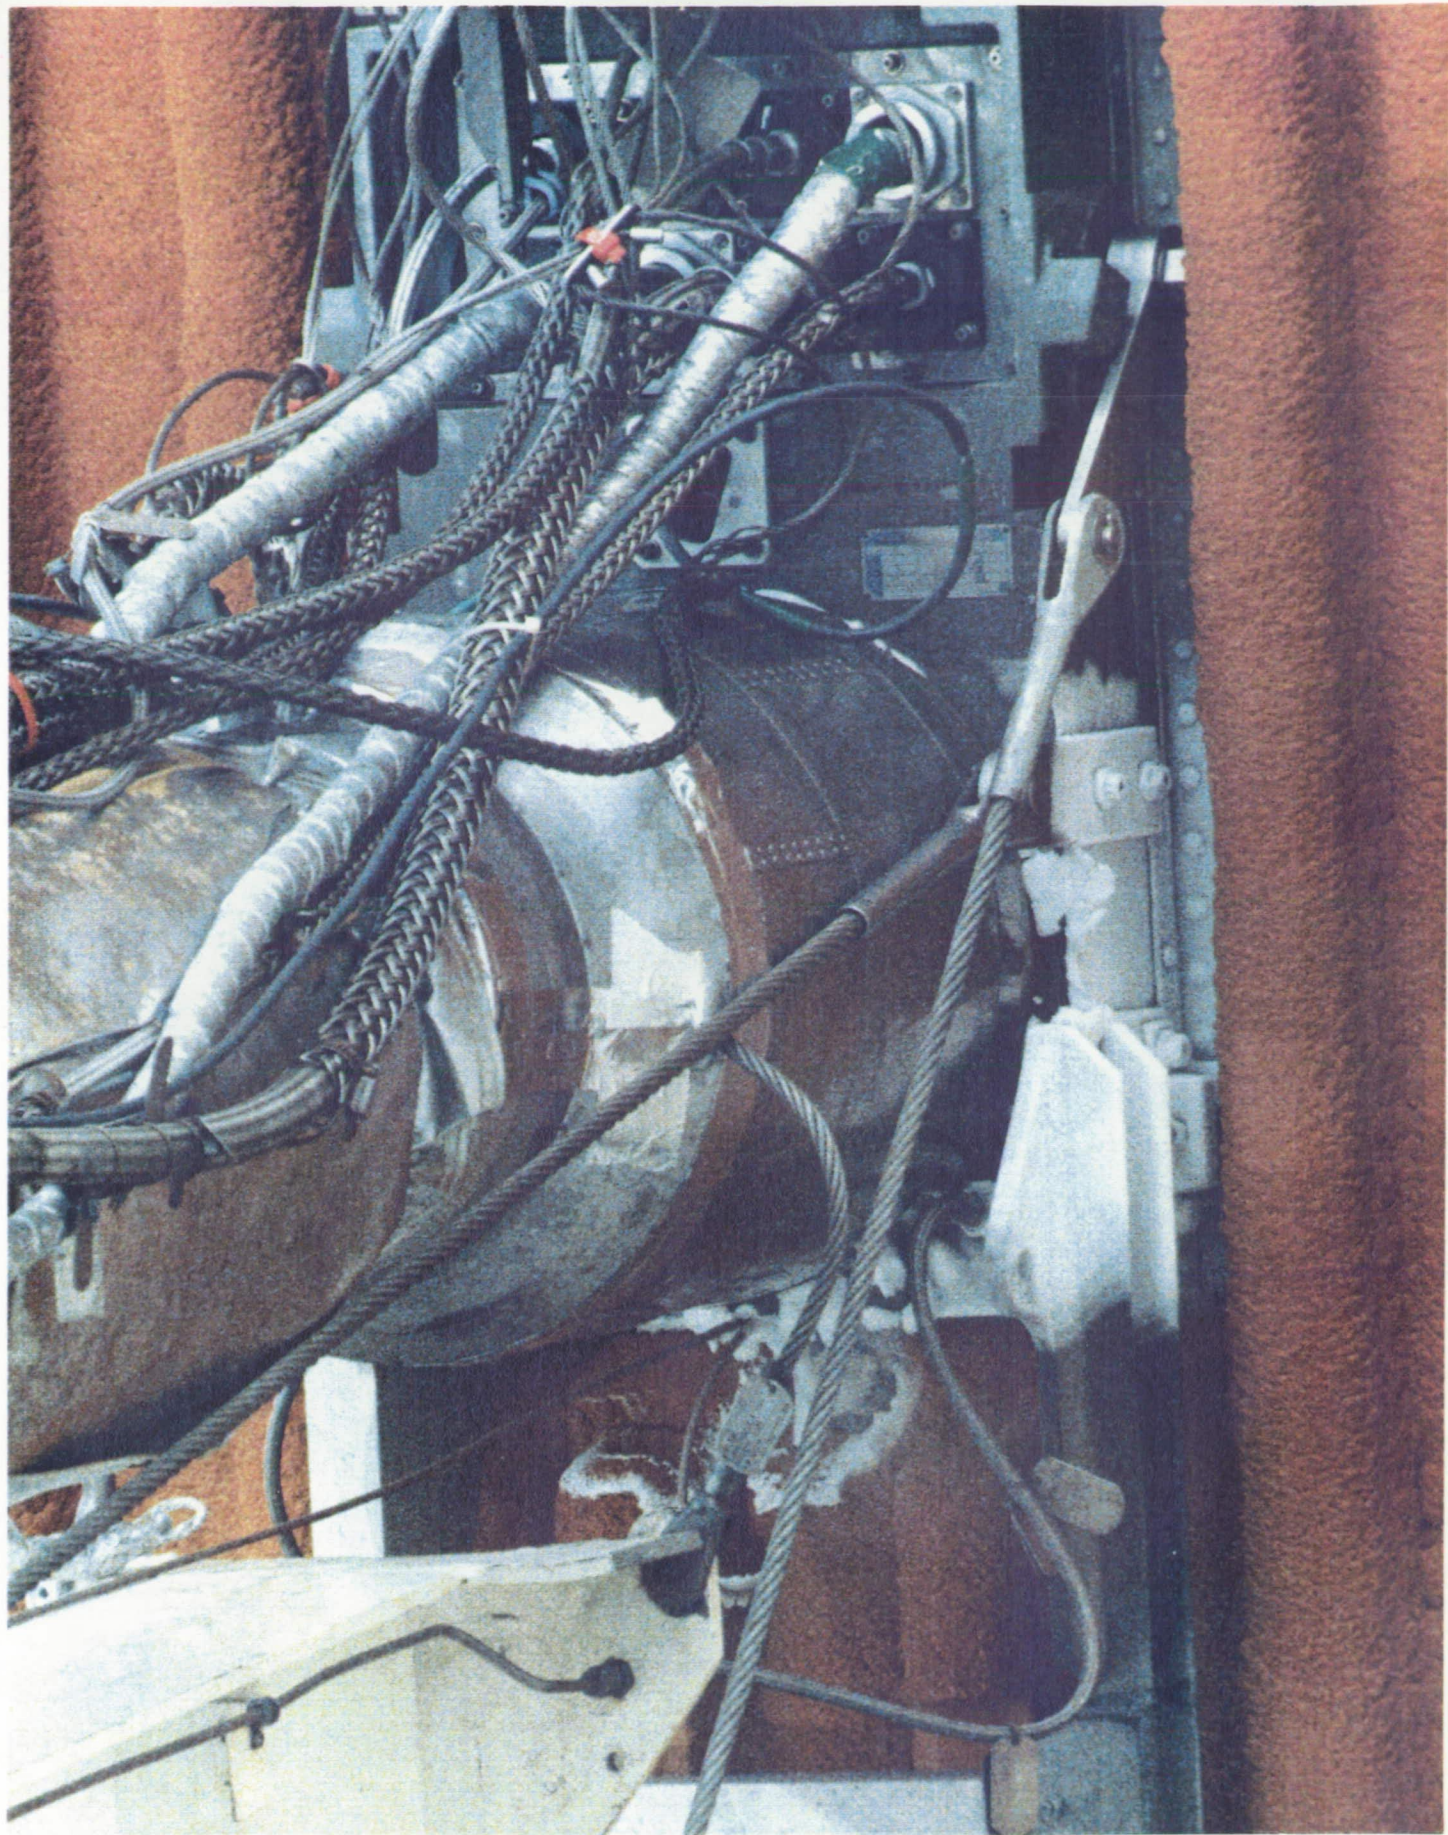
Typical ice/frost had accumulated on the GUCP legs and in the
TPS cut-out below the GH2 vent line

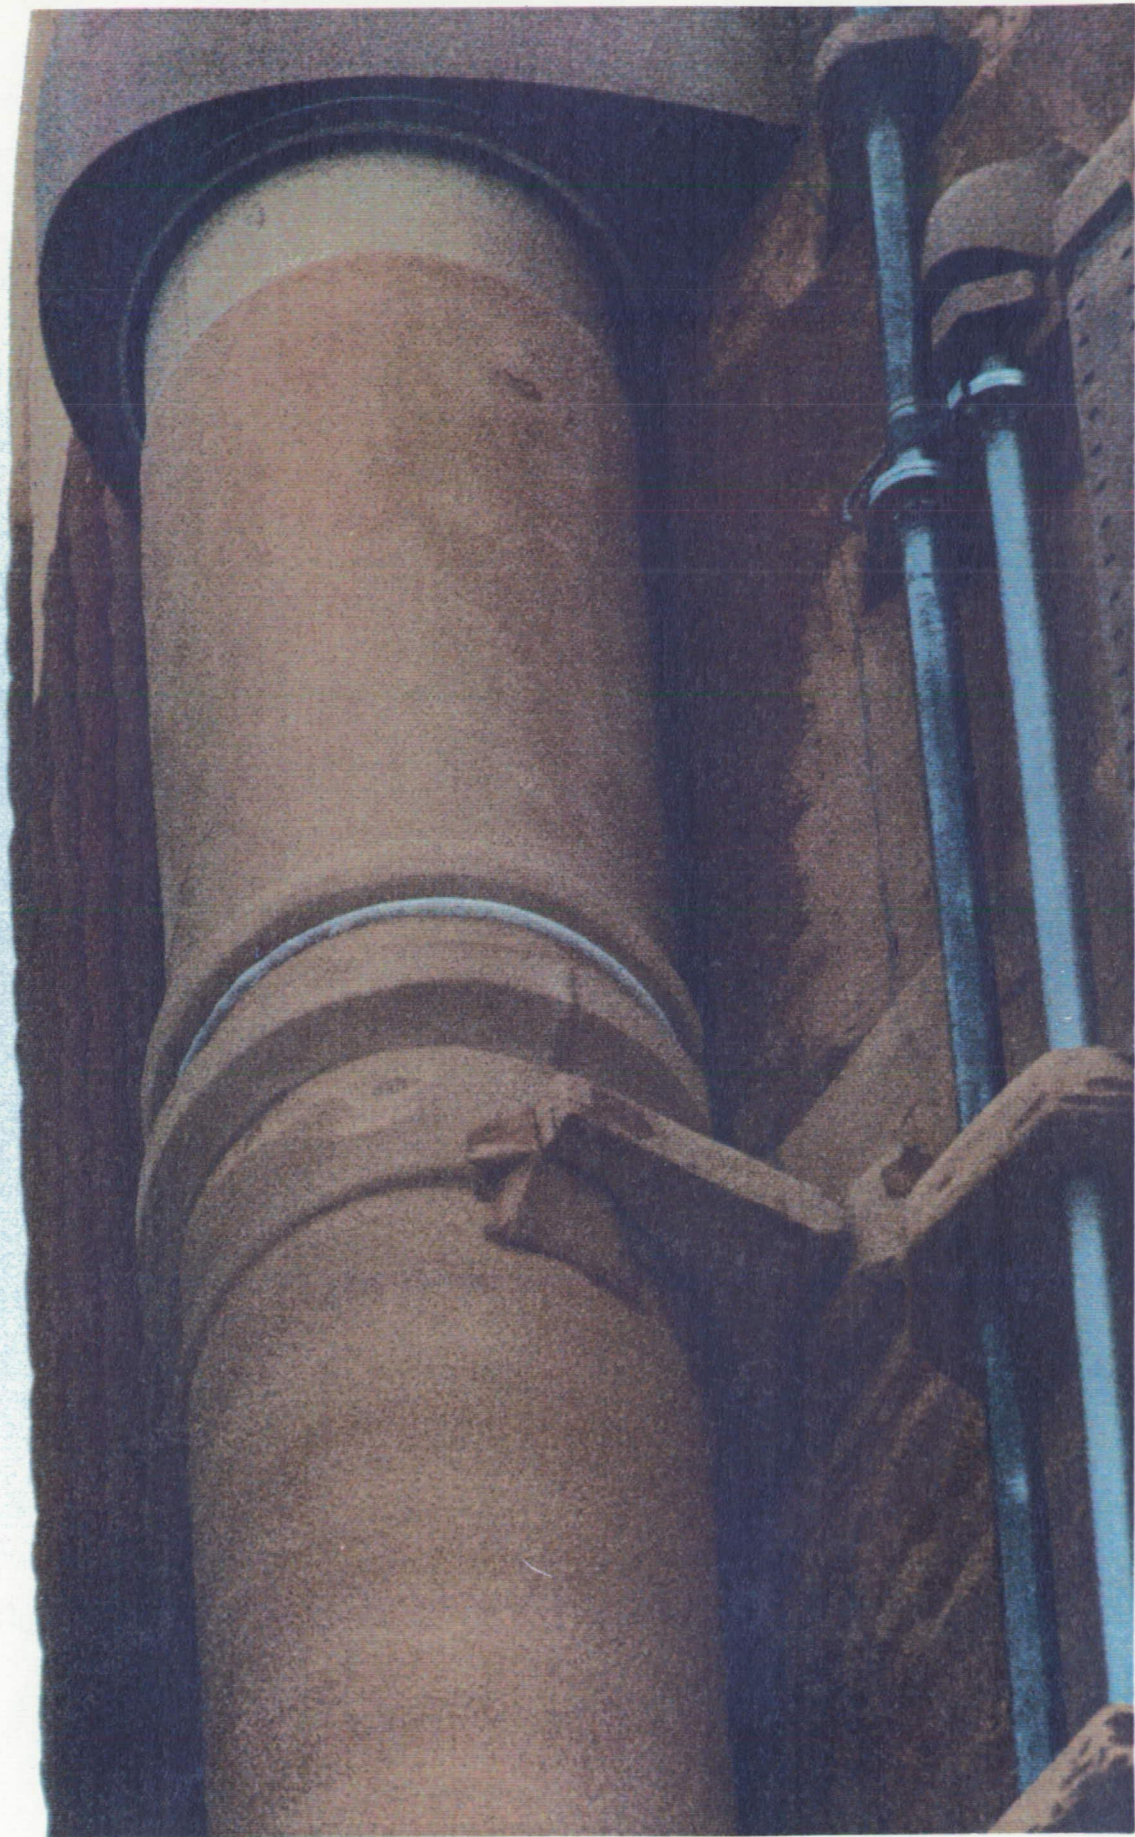
Typical ice/frost accumulation in the L02 feedline upper bellows and less-than-usual ice/frost in the support bracket

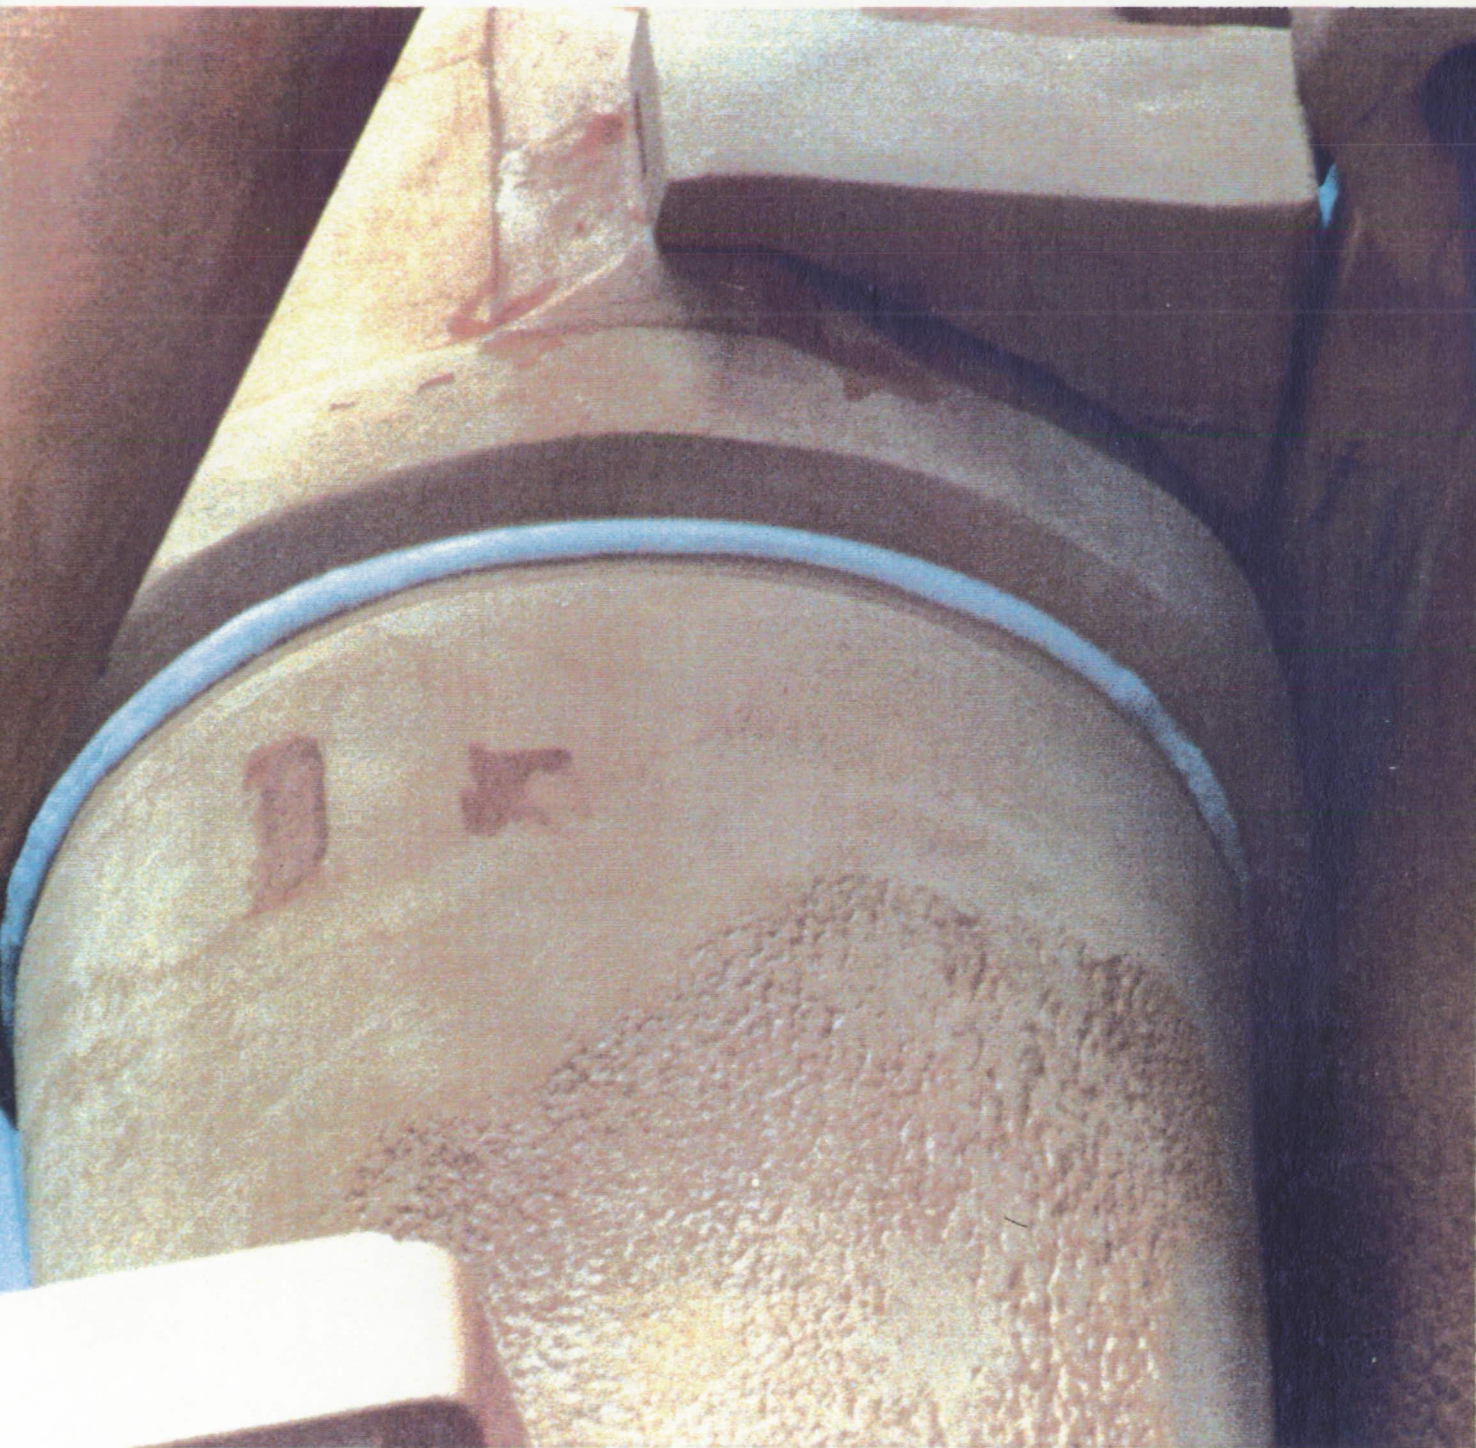
Typical ice/frost accumulation in the LO2 feedline lower bellows and less-than-usual ice/frost in the support brackets

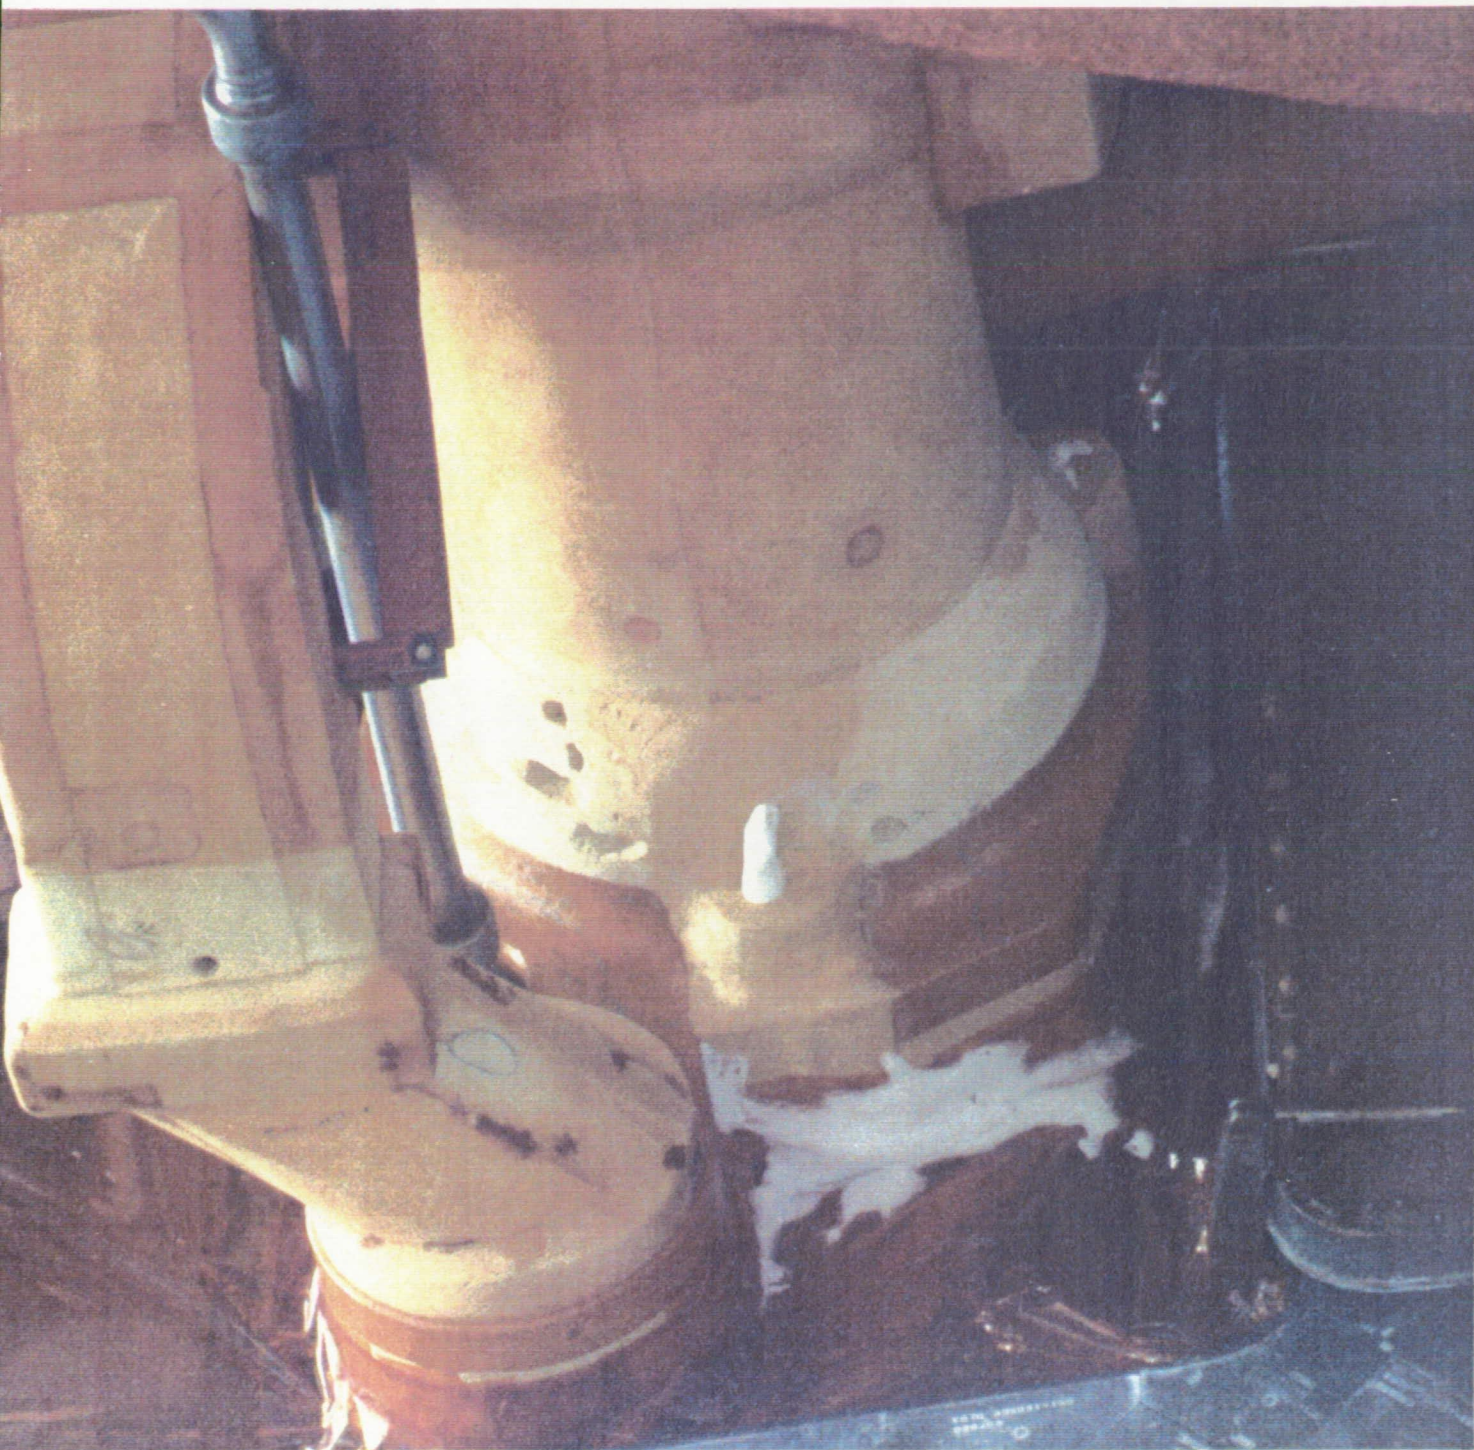
Typical ice/frost formations on the ET/ORB L02 umbilical purge barrier and pyro canister purge vents. Venting of nitrogen purge gas through the purge vents was normal.

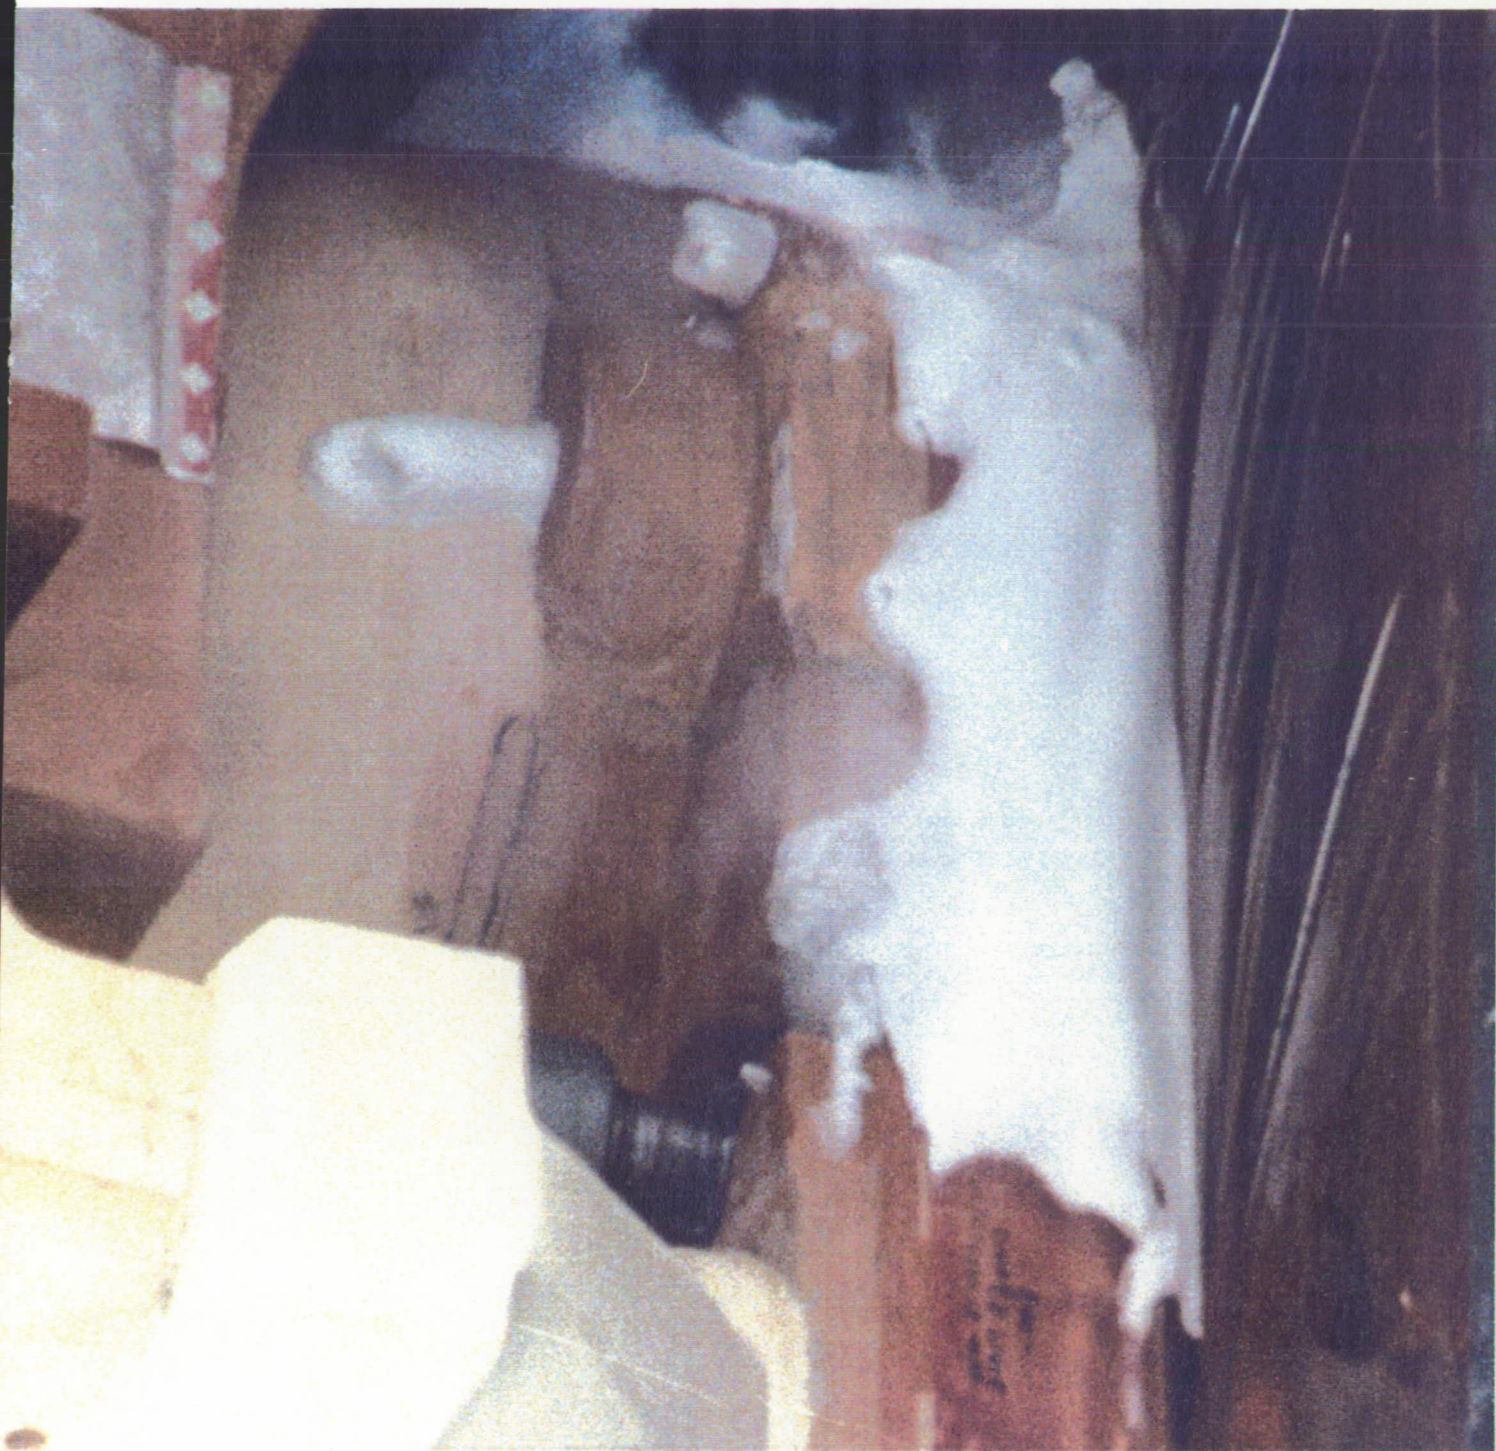
Typical ice/frost formations on the ET/ORB LH2 umbilical purge barrier top and outboard sides, the upper plate gap purge vent, and the forward outboard pyrotechnic canister purge vent.

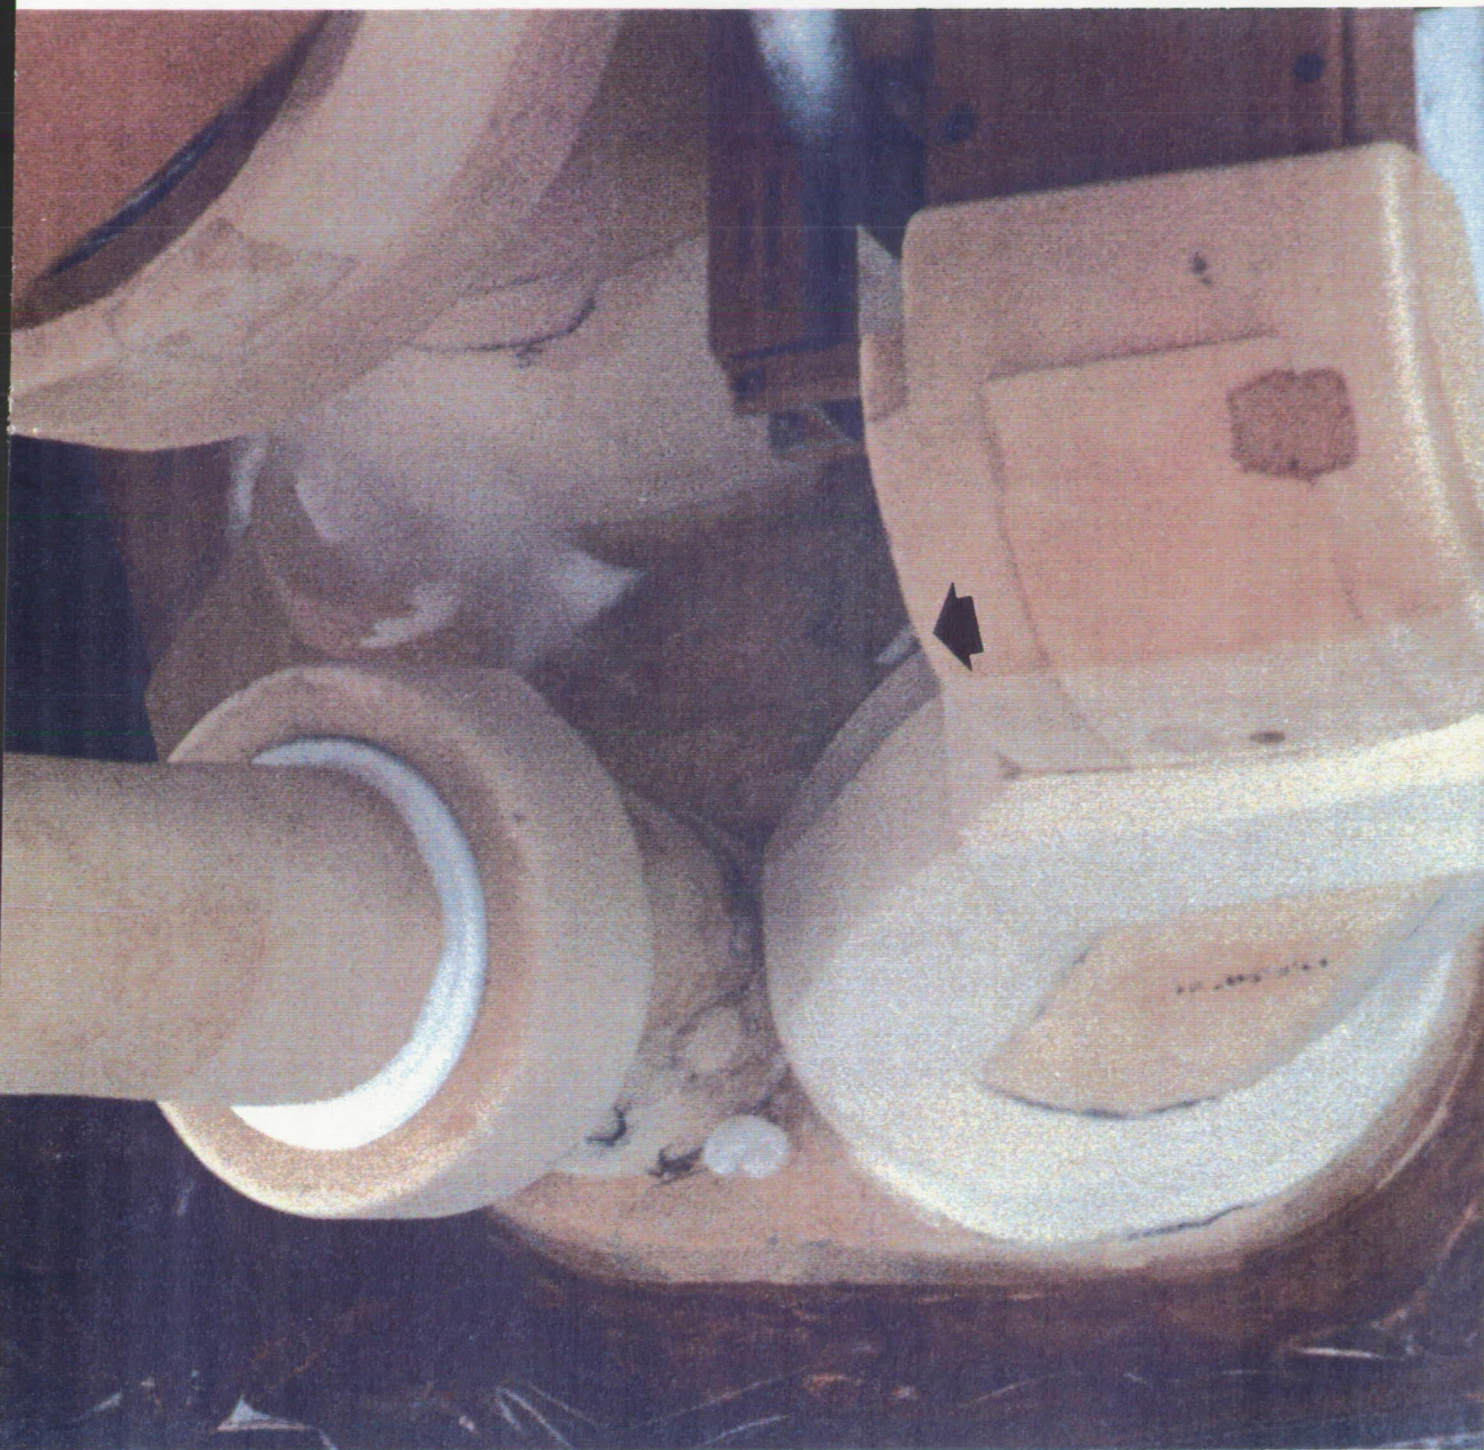
Typical ice/frost formations on the ET/ORB LH2 umbilical lower plate gap purge vent, lower pyro canister purge vent, and LH2 recirculation line upper bellows. Venting of cold helium purge gas from the pyro canister purge vent was normal. Note small frost spot on 17-inch flapper valve tool access port foam plug closeout bondline. Small frost spots also formed on lower pyro can TPS bondlines due to thermal shorts.

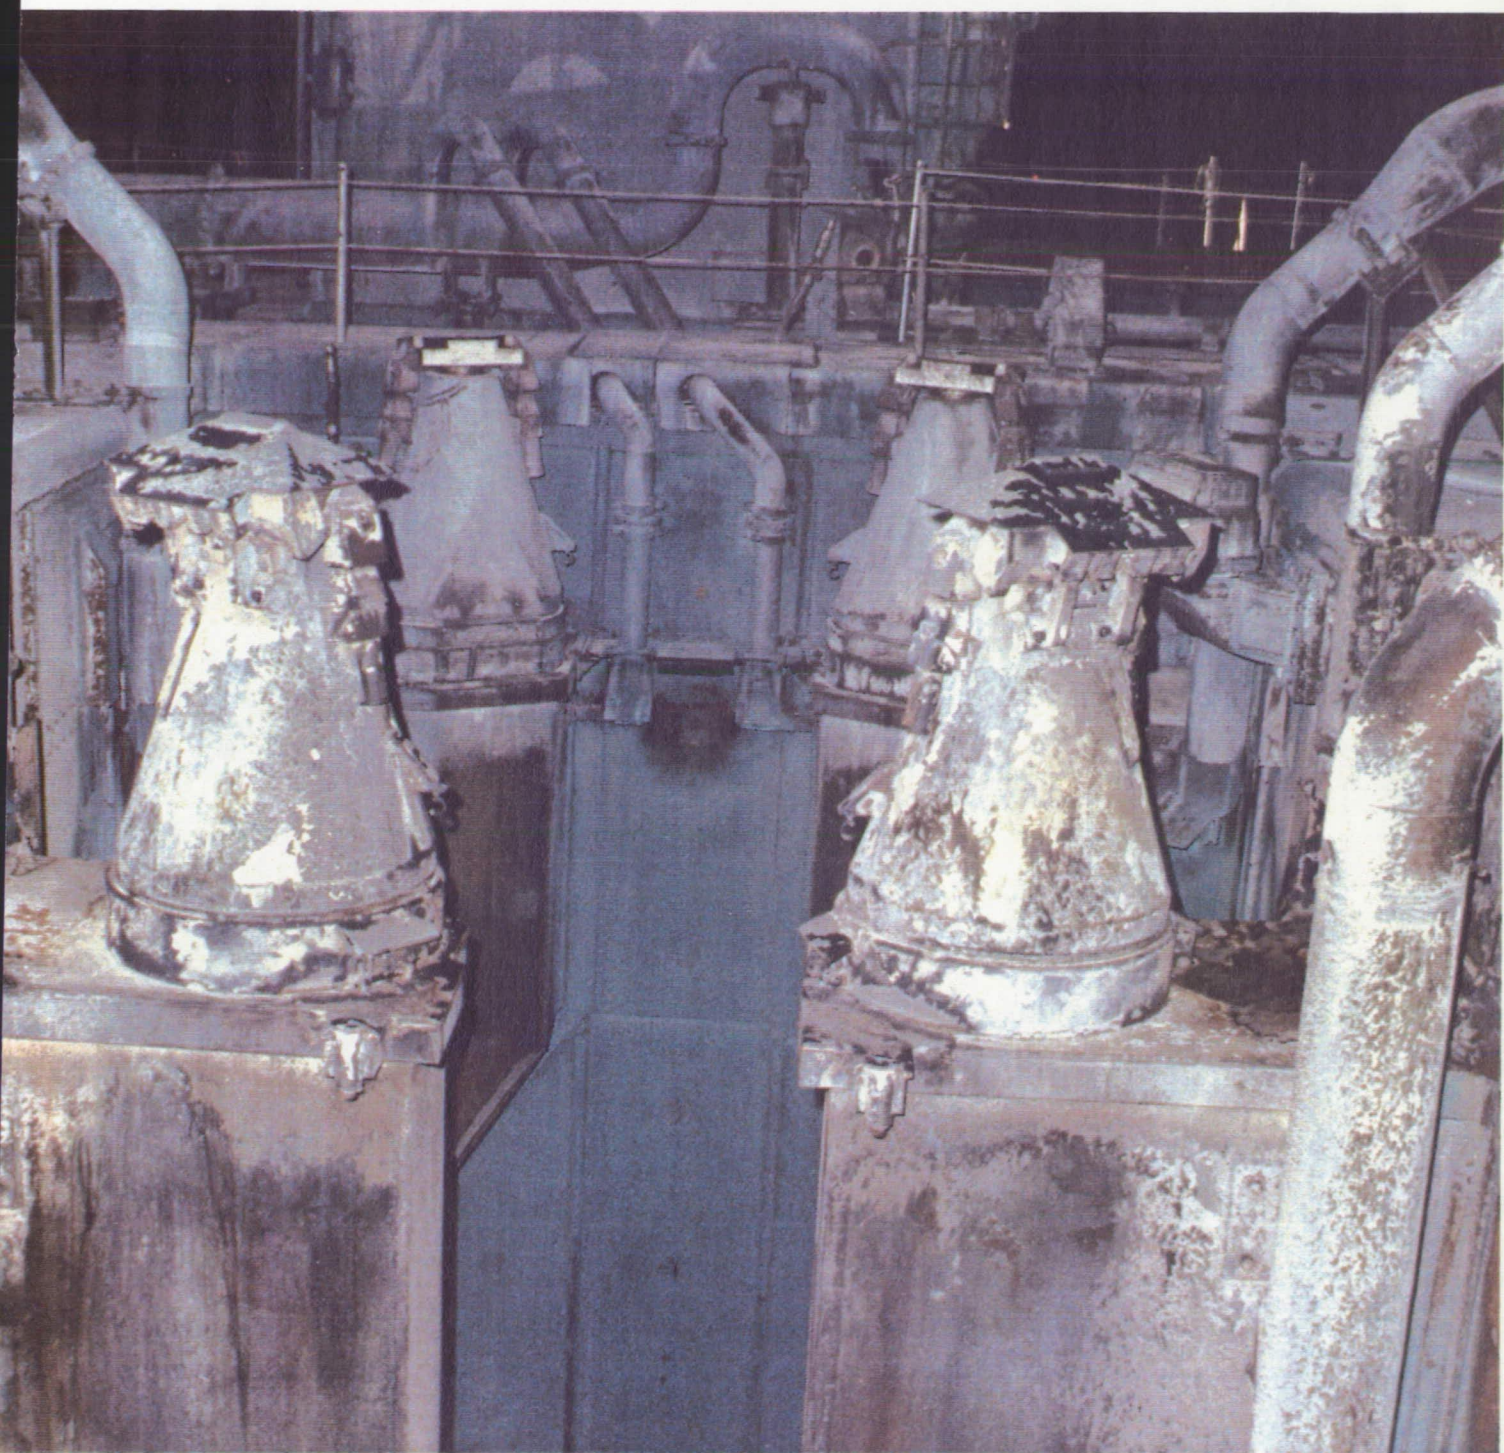
Post launch condition of RH SRB holddown posts. Note SRB plume effects on north posts compared to little effect on south posts
